**Flood Control Project Maintenance
Levee Inspections**

Maintenance Issue Types Only, Levee Inspection Report By Mile - Fall 2015

Reclamation District No. 0017 Mossdale

Waterway	Bank	Unit Miles	Inspection Start/End	Inspector
Unit No. 02 San Joaquin River	Right	14.27	10/15/2015 10/15/2015	Richard Willoughby

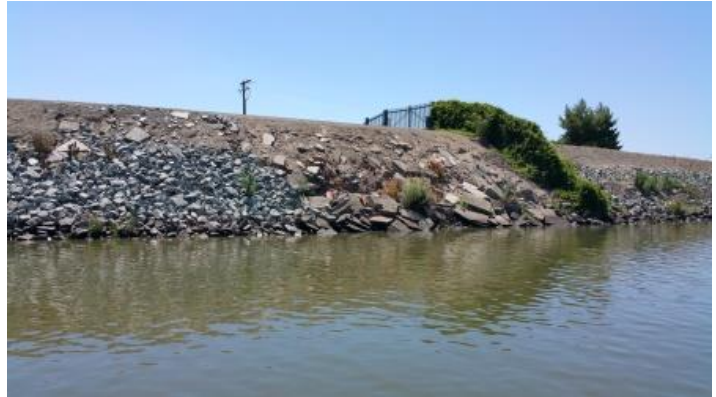
Photo 1 of 2 : SJR2015_RD0017U02RM44.32_1.jpg

LM Start	1.08	Rating **	U	Issue No.	2
LM End	1.08	Issue Type +	Ma	Location *	WS
Category	Supplemental			GPS Latitude/Longitude	
				Start	End
Item	DWR Erosion Survey			37.902530 °	37.902530 °
				-121.325690 °	-121.325690 °
DWR ID					
Action/Comments					
Inspector Comments: 06/24/2015: No significant change observed. 6/19/2014: No significant change observed. 08/13/2013: No significant change at this site. 08/07/2012: The erosion is nearly vertical, and has developed upward to halfway of the levee slope. The protecting concrete blocks have been washed away. Animal activities are visible. [2015 Site ID:RD0017U02RM44.32]

Front view of the erosion site. Note the concrete blocks and vegetation.

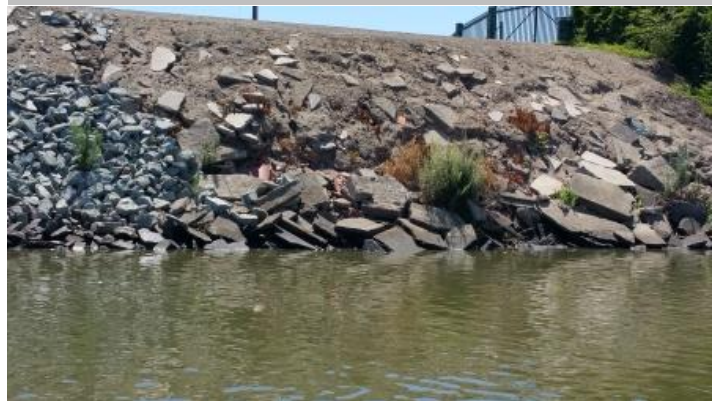
Photo 2 of 2 : SJR2015_RD0017U02RM44.32_3.jpg

Close view of the erosion.

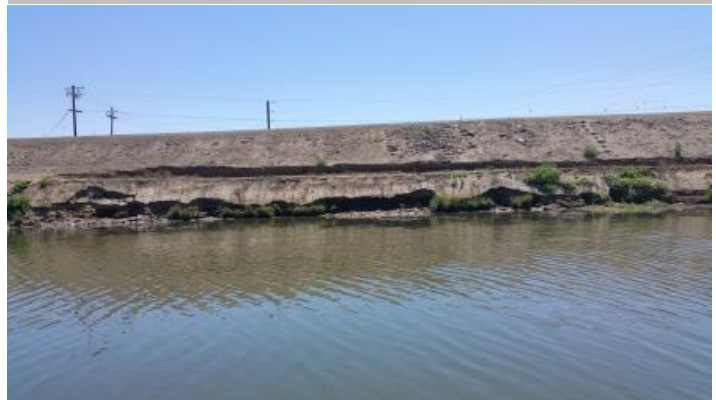
Photo 1 of 2 : SJR2015_RD0017U02RM45.95_1.JPG

LM Start	2.67	Rating **	M	Issue No.	6
LM End	2.69	Issue Type +	Ma	Location *	WS
Category	Supplemental			GPS Latitude/Longitude	
				Start	End
Item	DWR Erosion Survey			37.880710 °	37.880710 °
				-121.332200 °	-121.332200 °
DWR ID					
Action/Comments					
Inspector Comments: 06/24/2015: Levee has been cut at the mid slope and a temporary step has been made for unknow purpose. More erosion has been found at the site. 6/19/2014: The erosion is in the river bank which has an estimated 10-ft wide berm. [2015 Site ID:RD0017U02RM45.95]

Front view of the erosion site. Note the new cut at the middle levee slope.

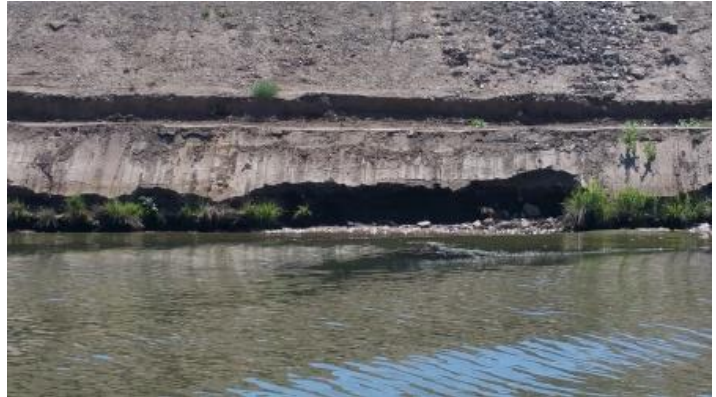
Photo 2 of 2 : SJR2015_RD0017U02RM45.95_4.JPG

Close view of the erosion.

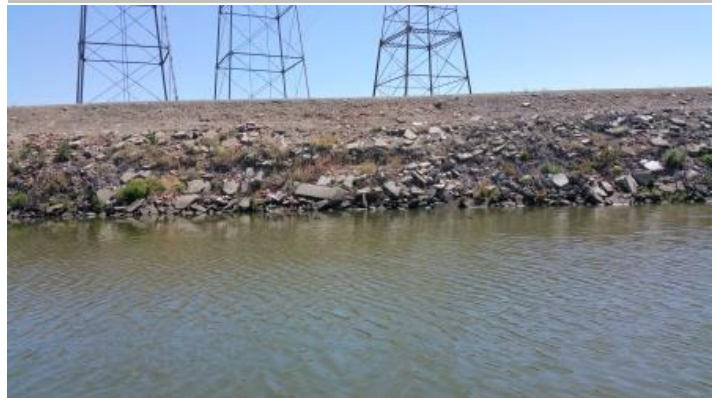
Photo 1 of 2 : SJR2015_RD0017U02RM46.10_1.JPG

LM Start	2.82	Rating **	M	Issue No.	8
LM End	2.82	Issue Type +	Ma	Location *	WS
Category	Supplemental			GPS Latitude/Longitude	
				Start	End
Item	DWR Erosion Survey			37.878660 °	37.878660 °
				-121.332400 °	-121.332400 °
DWR ID					
Action/Comments					
Inspector Comments: 06/24/2015: No significant change observed. 06/19/2014: A pocket erosion was found during the boat survey. [2015 Site ID:RD0017U02RM46.1]

Front view of the erosion.

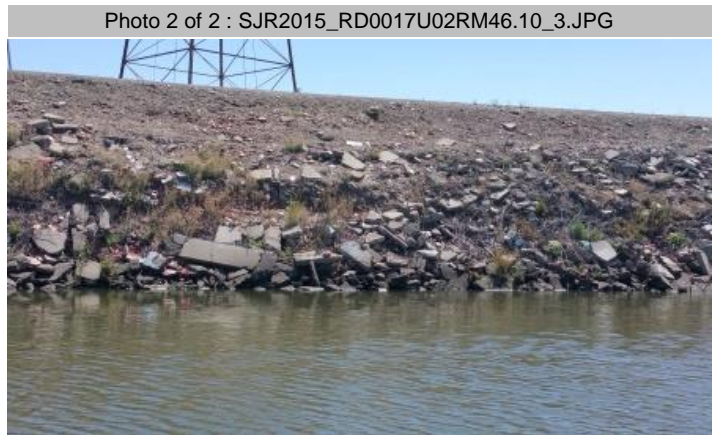
Close view of the erosion. The slope protection is poor.

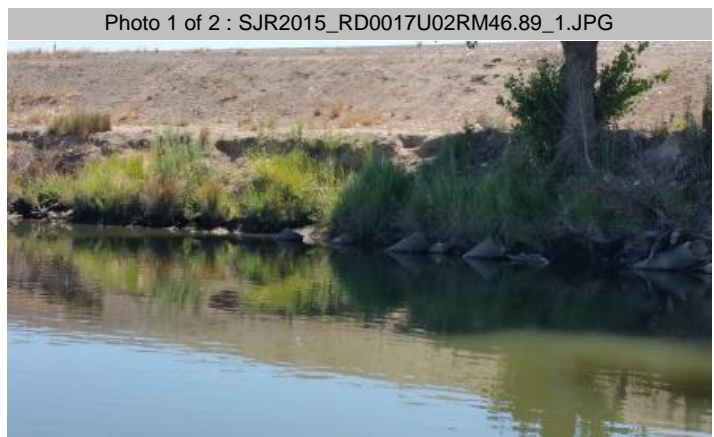
LM Start	3.63	Rating **	M	Issue No.	10
LM End	3.63	Issue Type +	Ma	Location *	WS
Category	Supplemental			GPS Latitude/Longitude	
				Start	End
Item	DWR Erosion Survey			37.868500 °	37.868500 °
				-121.327670 °	-121.327670 °
DWR ID					
Action/Comments					
Inspector Comments: 06/24/2015: No significant change observed. 06/19/2014: The erosion is near a large tree and probably has been caused by the irrigation pipe on the site. [2015 Site ID:RD0017U02RM46.89]

Front view of the erosion. Note the tree and the irrigation pipe.

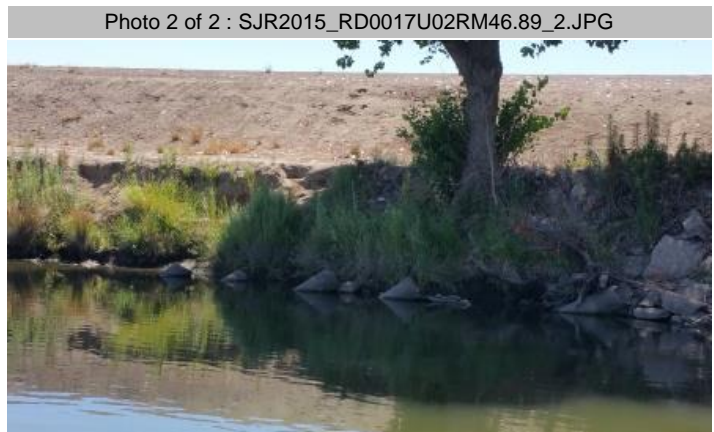
Close view of the erosion.

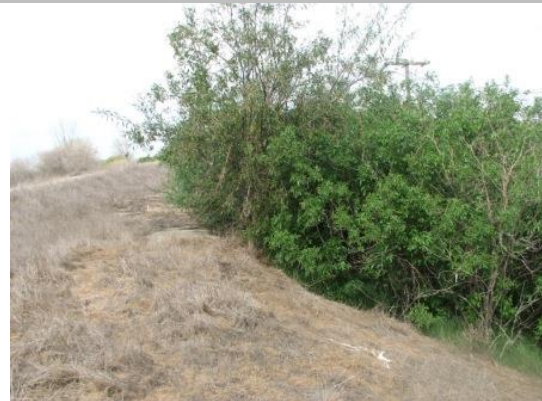
Photo 1 of 1 : FA_2015_RD0017_304_25_20150914_00007.jpg

LM Start	7.58	Rating **	M	Issue No.	25
LM End	7.60	Issue Type +	Ma	Location *	LS
Category	Earthen Levee			GPS Latitude/Longitude	
				Start	End
Item	Vegetation			37.828095 °	37.827920 °
				-121.309945 °	-121.309847 °
DWR ID	DWR_RD0017_02_s _ 2012_25				
Action/Comments					
Elderberries are blocking visibility and flood fight capability.

Elderberry blocking view of landside slope and toe.

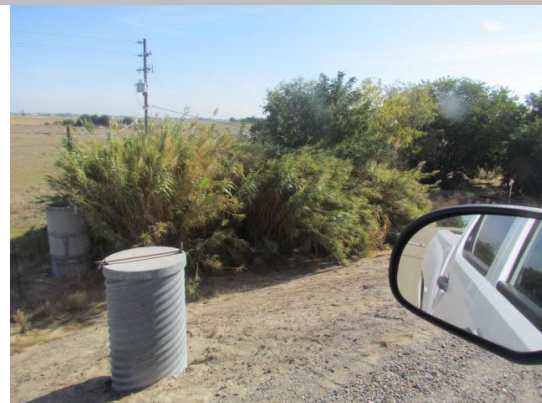
Photo 1 of 1 : FA_2015_RD0017_304_9_20150914_00005.jpg

LM Start	9.28	Rating **	U	Issue No.	9
LM End	9.28	Issue Type +	Ma	Location *	LS
Category	Earthen Levee			GPS Latitude/Longitude	
				Start	End
Item	Vegetation			37.815243 °	37.815243 °
				-121.317470 °	-121.317470 °
DWR ID	DWR_RD0017_02_s _ 2012_9				
Action/Comments					
Trees / Woody Vegetation					
Inspector Comments: Bamboo located at landward toe.

Looking east at bamboo at landward toe.
